Unintended Consequences

Reducing thermal bridging at junctions when designing and installing solid wall insulation

Caroline Weir, Tim Ward and Colin King

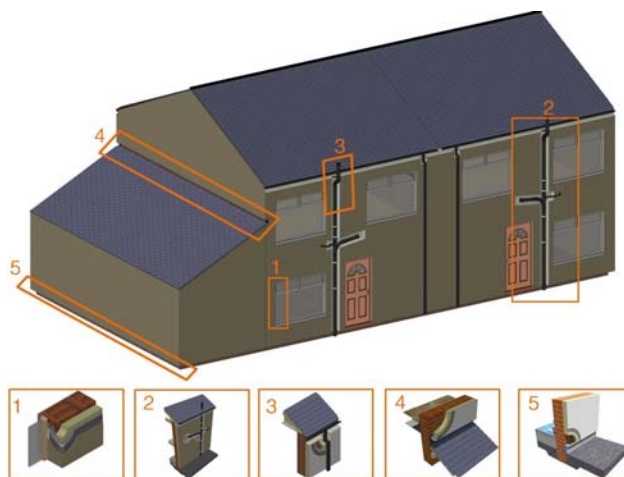
Typical Cold Bridging in EWI

- Heat loss through a localised area where the primary insulation layer is interrupted or significantly reduced
- Difficult but not impossible to treat in solid wall insulation
- Become more significant where the building fabric has been upgraded

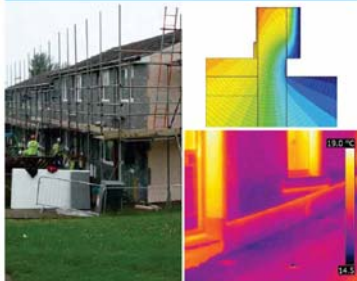
Table 6: Heat loss in example dwelling with external insulation and improved detailing at key junctions

Junction	Length (m)	U-value (W/m ² K)	Total (W/K)
Ground floor/external wall	20.0	0.154	3.08
Internal floor/external wall	20.0	-0.001	-0.02
Eaves	12.0	0.042	0.50
Gable	8.0	0.258	2.06
Head	8.0	0.064	0.51
Sill	8.0	0.110	0.88
Jamb	22.8	0.056	1.28
Corner	10.0	0.112	1.12
Party wall/external wall	10.0	0.329	3.29
Ground floor/party wall	8.0	-0.057	-0.46
Party wall/floor	8.0	0.179	1.43
Total heat loss from junctions			13.68
Fabric element	Area (m ²)	U-value (W/m ² K)	Total (W/K)
Walls	88.6	0.261	23.12
Floor	48.0	0.201	9.65
Roof	48.0	0.268	12.82
Windows	11.4	2.200	25.08
Total heat loss from fabric elements			71.47
Overall heat loss			85.15
Junction loss as % of fabric loss			17.75

Table 7: Heat loss in example dwelling with external insulation and improved detailing at key junctions

Junction	Length (m)	U-value (W/m ² K)	Total (W/K)
Ground floor/external wall	20.0	0.289	5.86
Internal floor/external wall	20.0	-0.002	-0.05
Eaves	12.0	0.028	0.34
Gable	8.0	0.041	0.33
Head	8.0	0.060	0.48
Sill	8.0	0.049	0.39
Jamb	22.8	0.050	1.15
Corner	10.0	0.021	0.21
Party wall/external wall	10.0	0.169	1.69
Ground floor/party wall	8.0	-0.057	-0.46
Party wall/floor	8.0	0.179	1.43
Total heat loss from junctions			11.34
Fabric element	Area (m ²)	U-value (W/m ² K)	Total (W/K)
Walls	88.6	0.261	23.12
Floor	48.0	0.201	9.65
Roof	48.0	0.268	12.82
Windows	11.4	2.200	25.08
Total heat loss from fabric elements			76.67
Overall heat loss			88.01
Junction loss as % of fabric loss			14.77

Detail	IWI	EWI
Typical	36.3%	49.36%
Improved	17.78%	14.77%

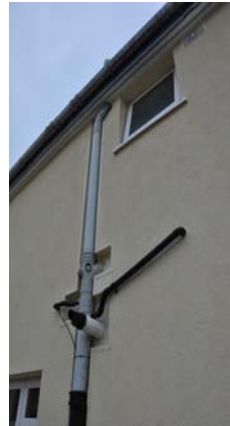
Hillingdon, London

The Thermo-Pro range of profiles have been developed to provide a weather tight and thermal bridging solution for external wall insulation systems.

- Soil Pipes
- Gutters and Downpipes
- Gateposts
- Satellite Dishes
- Window Installation

- Faster Installations
- Reduce risk of onsite damage
- Superior Weatherproofed and pre-finished solution
- No thermal breaks in EWI
- Reduced disruption to access

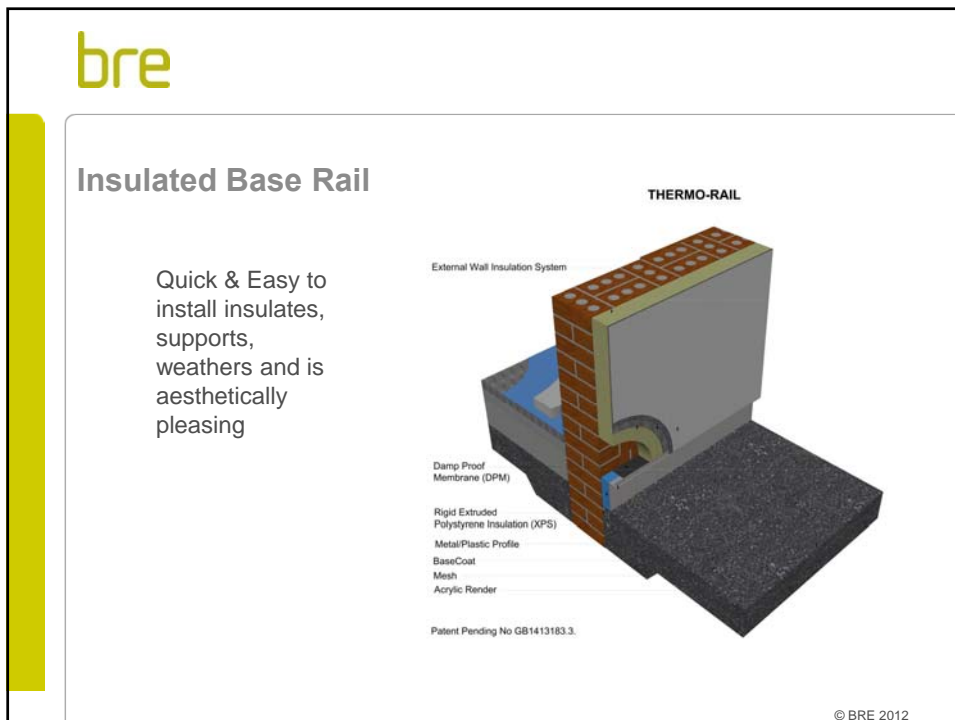
Without

16.3°C

Linear Thermal Transmittance
 $\Psi = 0.718 \text{ W/mK}$

With

18.5°C

Linear Thermal Transmittance
 $\Psi = 0.207 \text{ W/mK}$

Thermal Graphics

By introducing the insulated profile the linear thermal transmittance is reduced by over **70%** and the internal surface temperature is increased by 2.2°C significantly reducing the risk of condensation creating a healthy indoor environment.

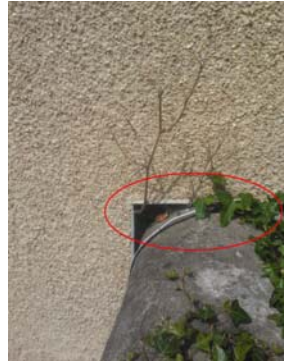
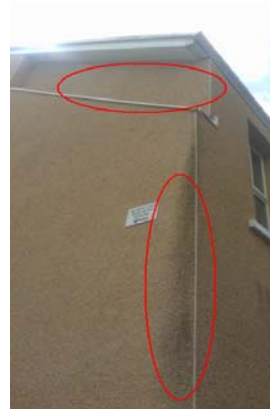
Midlands

- Non insulated floor slab below plinth
- Condensation and mould in room corners

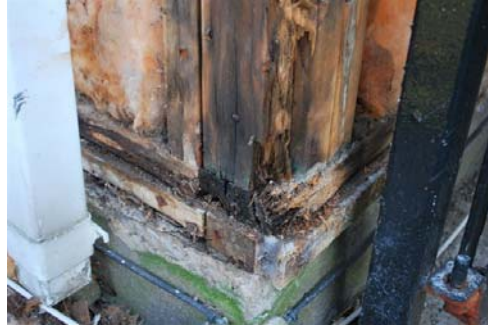
Timber Frame House

Built in 1967

Insulated in 2006

Wet rot, structural failure
2012

- water ingress
- poor detailing
- failure of sealant
- wet rot and dry rot
